## **Appendix D**

## Minor Projects PA Project Submittal and Assessment Form

The Wabash County Board of Commissioners proposes a project involving Wabash Co. Bridge 143 carrying County Road (CR) 1050 South over Grant Creek in Wabash County, Indiana (NBI #8500465). The project is within Liberty Township on the USGS La Fontaine Quadrangle, in Section 28, Township 26 North, Range 7 East.

**“WATERS OF THE U.S.” DETERMINATION REPORT**  
**Wabash County Bridge 143 over Grant Creek, Wabash County**  
**Bridge Replacement Project**  
**Des. No. 2003065**

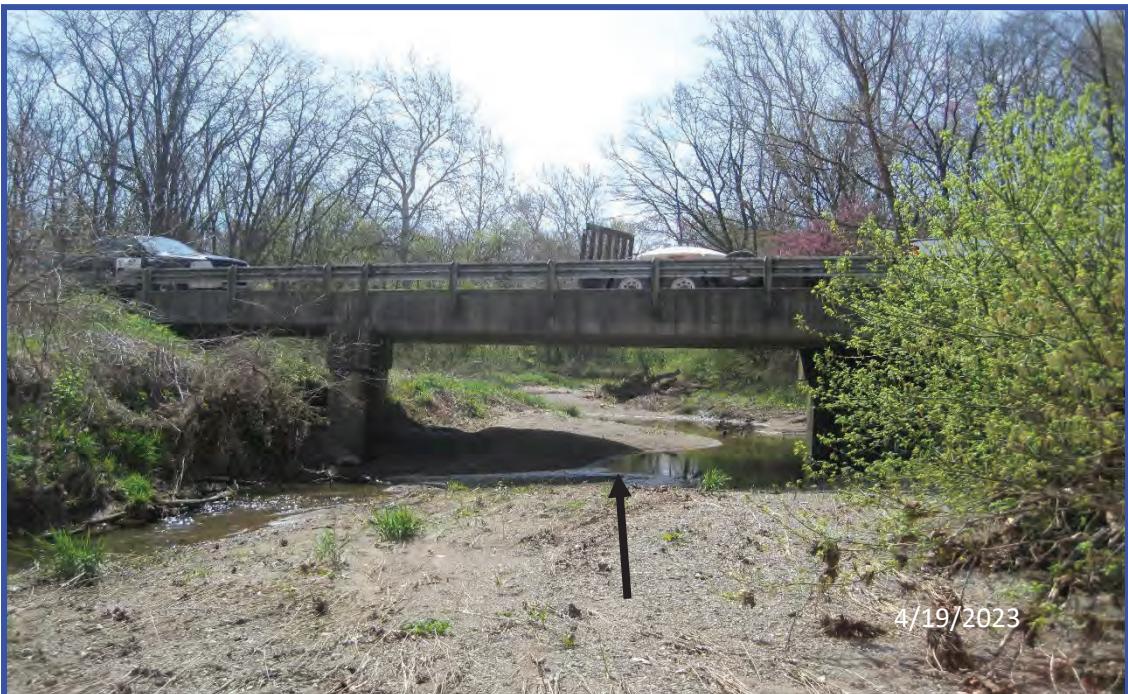
2) Looking south (upstream) at Grant Creek passing beneath Bridge 143

One (1) mapped waterway was observed within the study area. This waterway is known as Grant Creek and is identified as a perennial USGS blue line stream that flows northwest through the project area, and discharges into Mississinewa River approximately 2.5 miles downstream of the study location. Grant Creek is within the backwater affected area of the Mississinewa River, making it flooded occasionally when the reservoir is allowed to fill to capacity. Grant Creek has a drainage area upstream of the study limits of approximately 8.382 square miles (as calculated using the web-tools on the USGS *Indiana StreamStats* website<sup>4</sup>) (Attachment 8). This waterway falls within the larger Grant Creek – Mississinewa River Watershed identified by the USGS HUC-12 051201030603. Grant Creek is classified as a riverine, lower perennial, unconsolidated bottom, permanently flooded (R2UBH) waterway. It is of average poor due to the lack of an intact riparian corridor, moderate sinuosity, and extreme bank erosion. Additionally, the stream channel is entrenched. The substrate is primarily gravel and assorted sizes of cobble. The creek has an approximate average 36.5-foot bankfull width and approximate average 2.24-foot bankfull depth. The OHWM depth is approximately 1.5 feet and width is approximately 18.0 feet. All stream measurements were taken at LAT/LONG 40.673860; -85.744168. During the site visit conducted on April 19, 2023, Grant Creek contained flowing water. Grant Creek is determined to be a “Waters of the U.S.” because it is a blue-line feature (jurisdictional stream) with an OHWM.

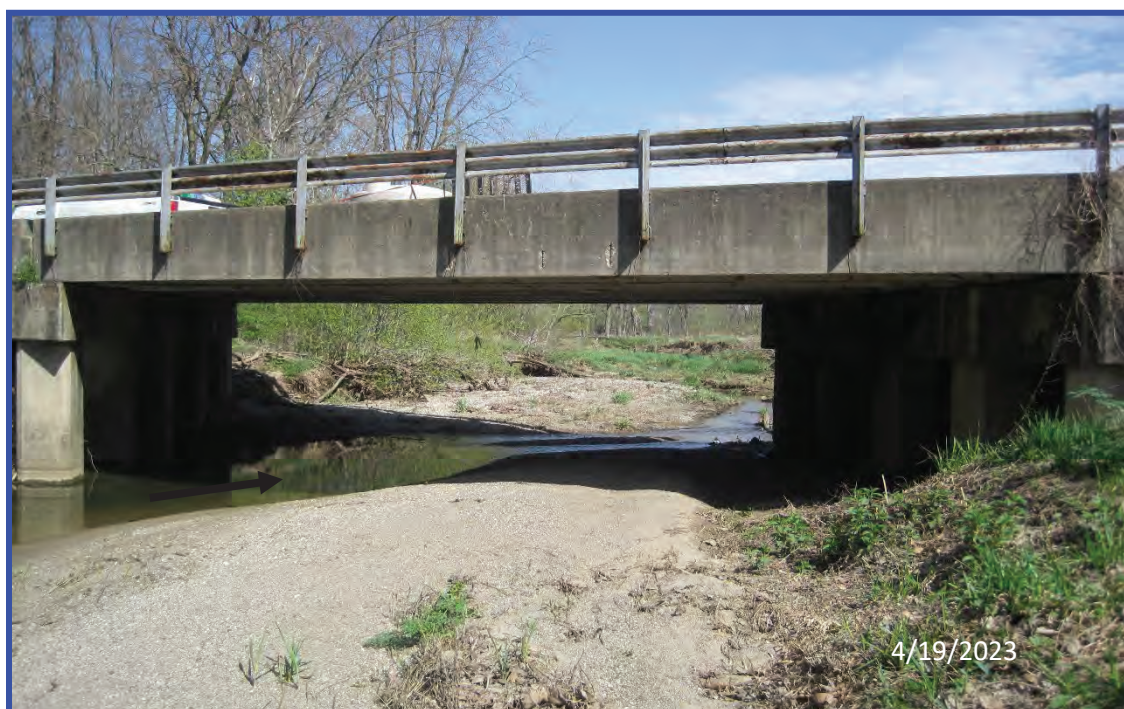
4) Looking north at the sandbar present along Grant Creek upstream of Bridge 143

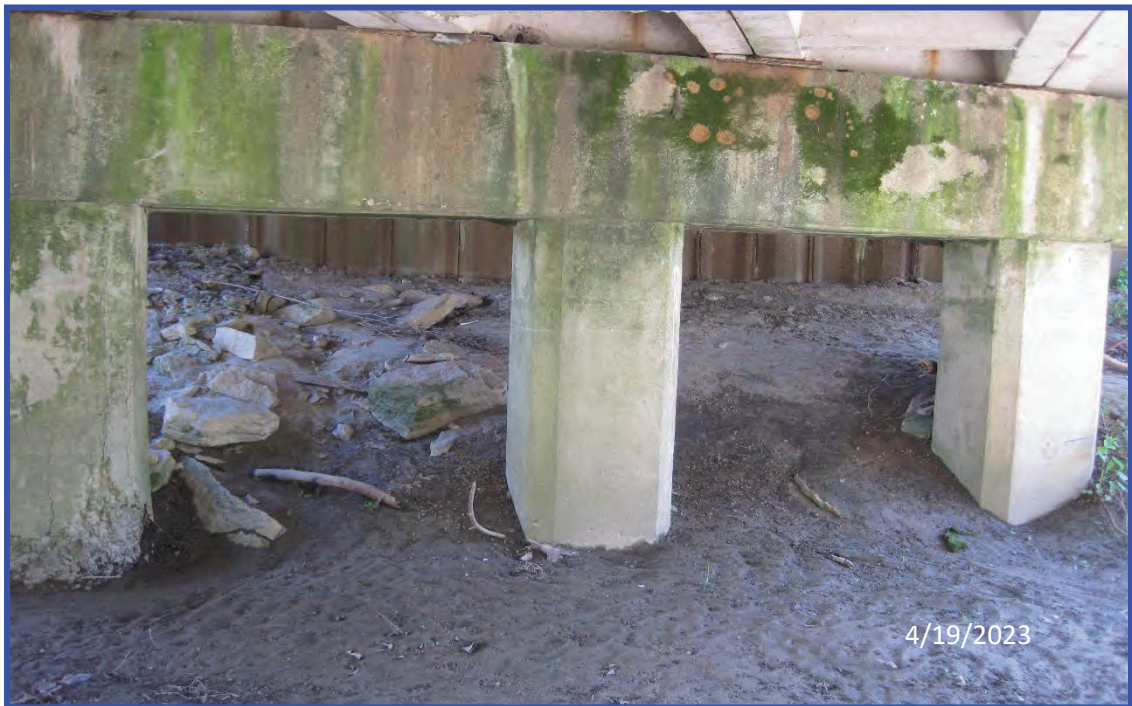
5) Looking at animal tracks and revetment present beneath the east span of Bridge 143

Raccoon and deer tracks were observed beneath Bridge 143 during the site investigation. Therefore, there is adequate opening for wildlife to pass beneath the bridge. Some stone revetment is present around the abutments. One abandoned bird nest was observed. No other evidence of birds or bats was observed using the bridge (Attachment 12, photo #5).

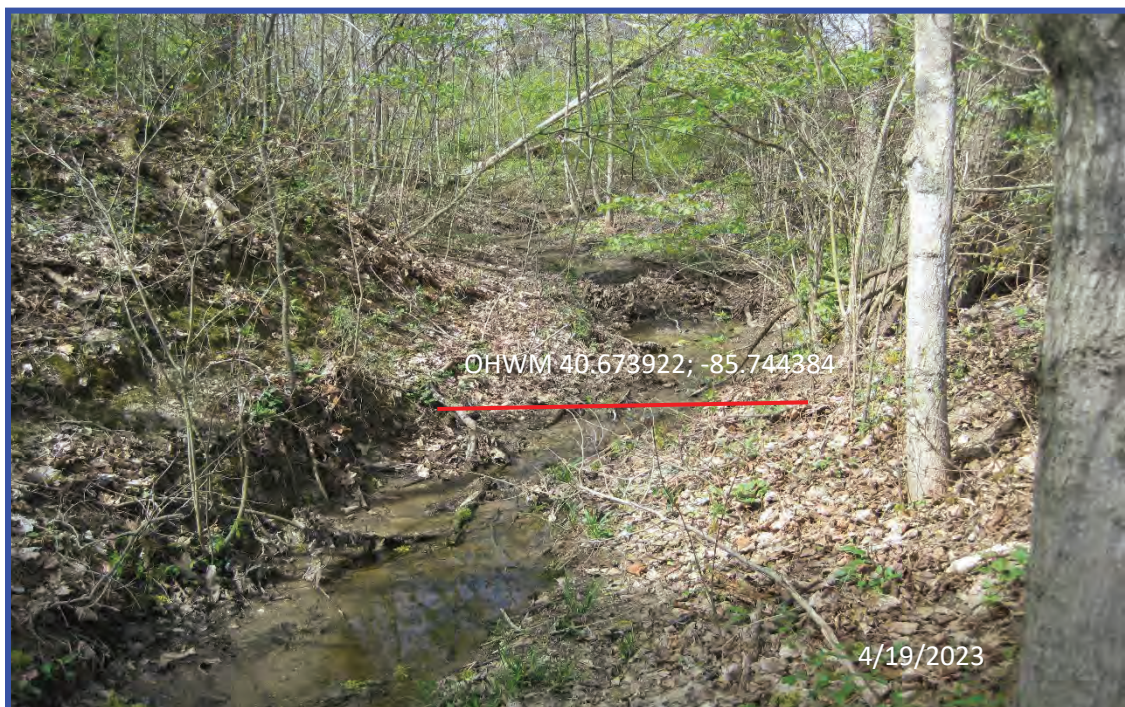
9) Looking west (upstream) at UNT to Grant Creek

An unmapped stream feature was observed in the southwest quadrant of Bridge 143. It begins approximately 700 feet southwest of the bridge. It begins in an agriculture field, flows northeast for approximately 400 feet, passes beneath a driveway, then continues approximately 120 before meeting with CR 1050. It then flows east along the southside of CR 1050 for approximately 180 feet before discharging into Grant Creek. This unmapped stream feature is identified as Unnamed Tributary (UNT) to Grant Creek for the purposes of this report. UNT to Grant Creek as a 2.5-foot OHWM width and a 5-inch OHWM depth. The substrate was primarily mud with gravel overlain.

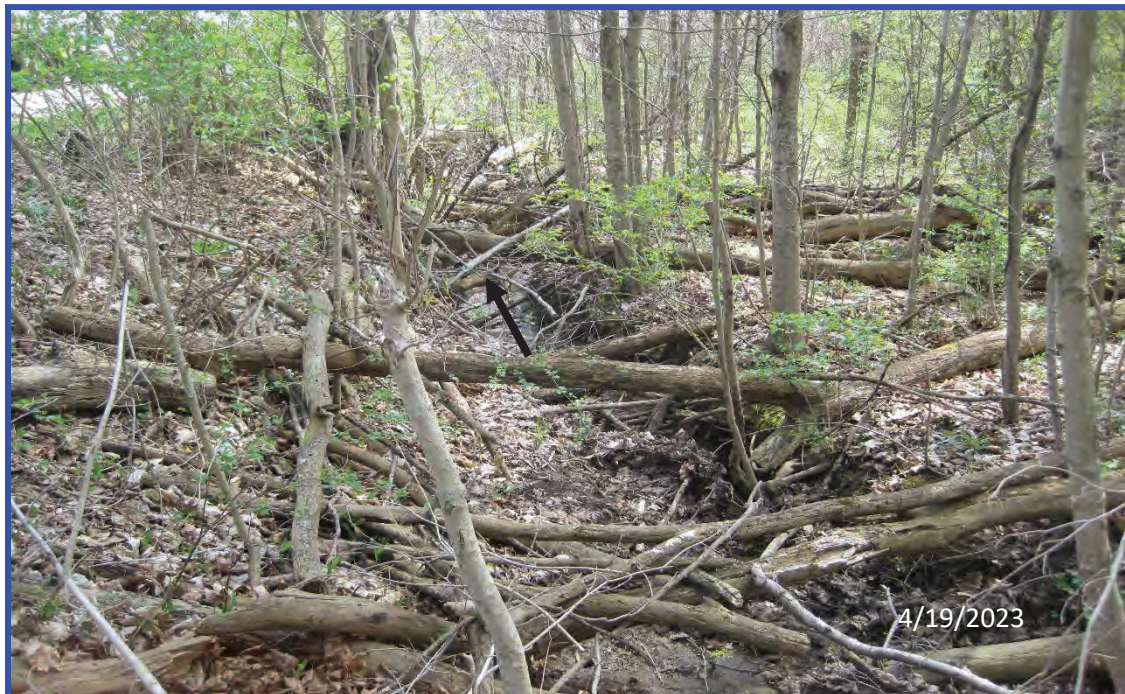
10) Looking southeast (downstream) at UNT to Grant Creek

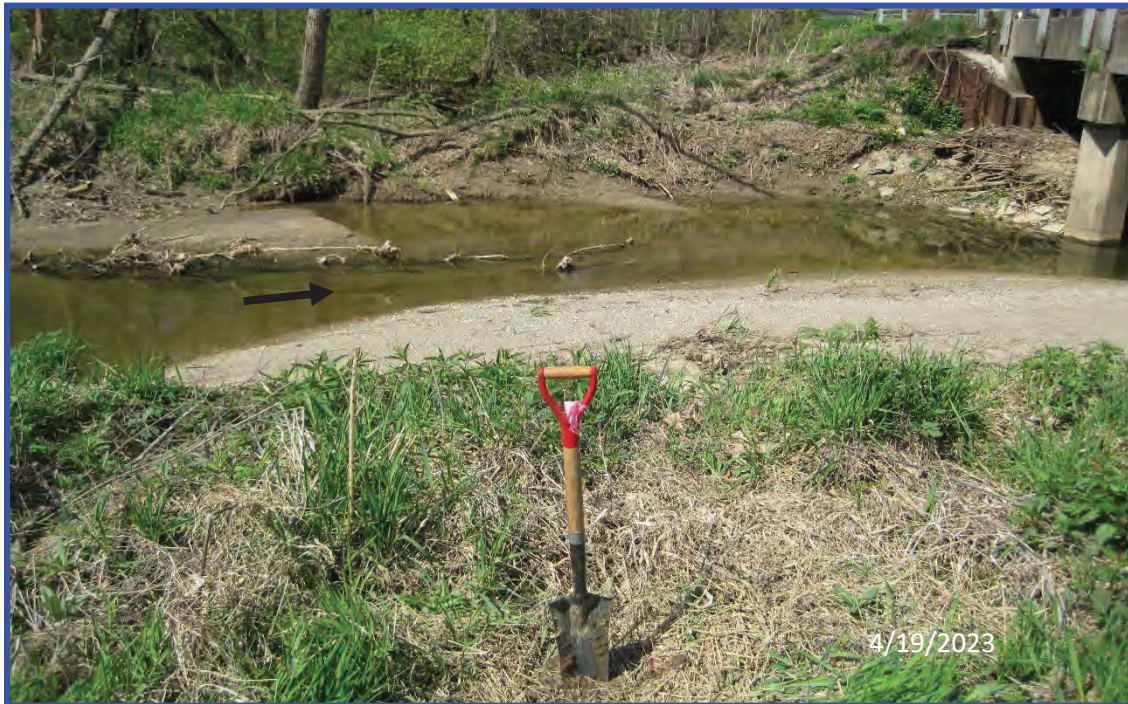
11) Looking west at Sampling Point 1 in the SE quadrant of Bridge 143

Sampling Point 1 was taken in a low contour area that indicated the potential for frequent or prolonged hydrology within the floodplain of Grant Creek. The area is mapped as Genesee loam, which has a low hydric inclusion rating of 7%. The soil profile matched the description for Genesee loam and did not contain any hydric soil field indicators. The area did not contain an overstory or understory. The dominant species was *Phalaris arundinacea*. This community is hydrophytic dominant. The soil was loamy and appeared well-drained. No evidence of frequent or prolonged hydrology was observed as the floodplain surface is approximately 2.5 feet above the water surface elevation of Grant Creek under normal conditions. This indicates that groundwater is found at least 30 inches below the surface. As a result, Sampling Point 1 is a non-wetland data point (Attachments 17 – 18).

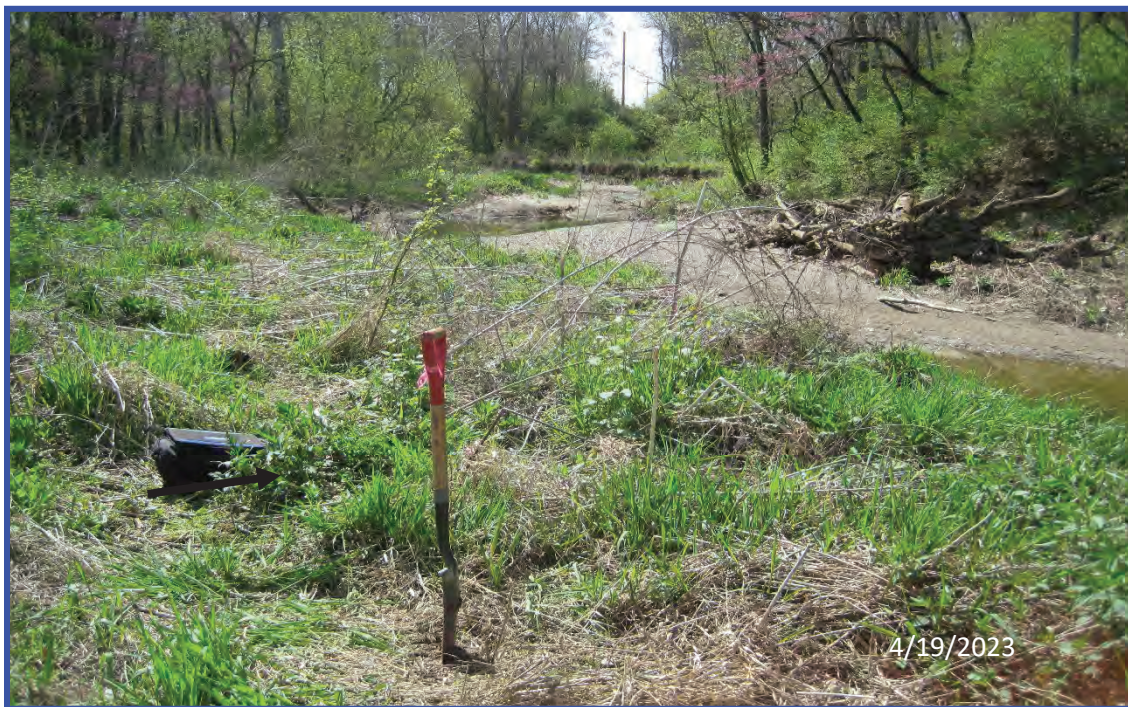
12) Looking south at Sampling Point 1 in the SE quadrant of Bridge 143

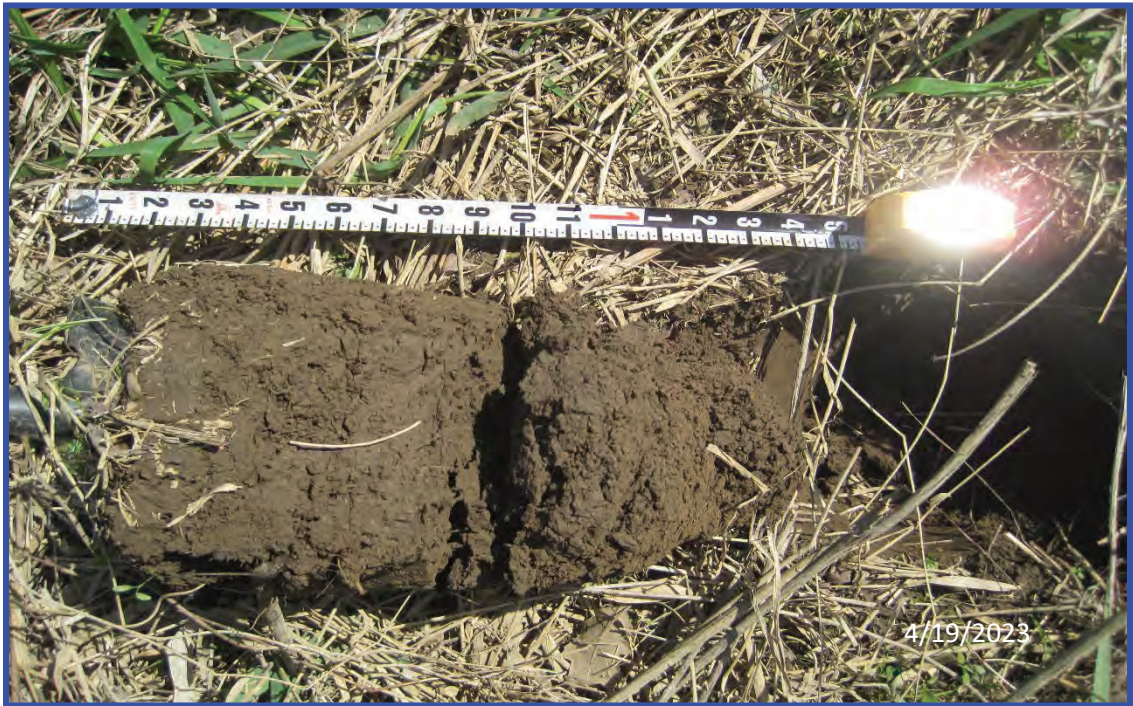
13) Looking at the soil sample taken at Sampling Point 1

Depth (Inches)	Matrix		Redox Features				Texture	Remarks
	Color (moist)	%	Color (moist)	%	Type*	Loc**		
0-18	10YR 4/2	100					Loam	<1 inch ribbon test

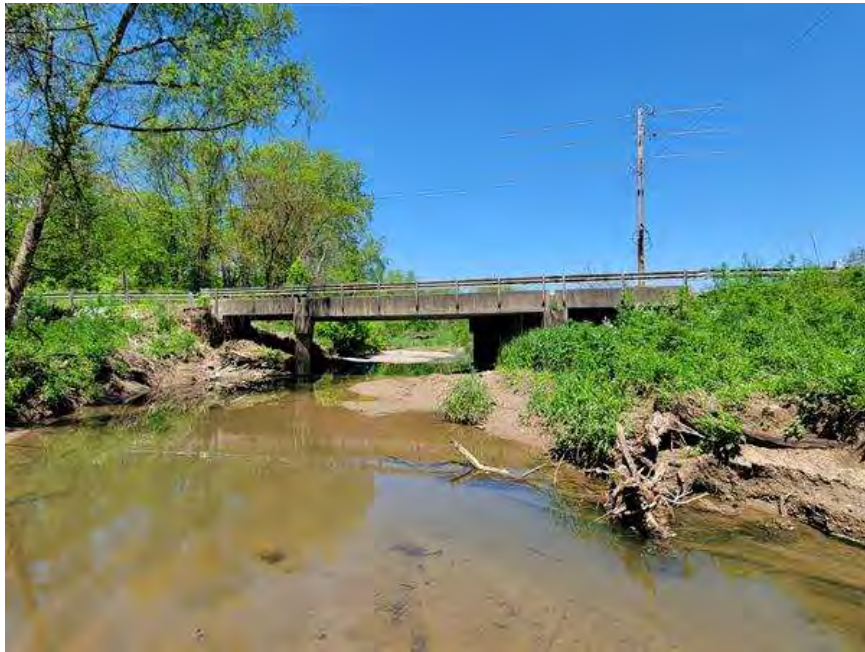
85-00143  
CR 1050 S  
over  
GRANT CREEK

WEARING SURFACE PATCHED, SPALLED, AND UNEVEN, CRACKS OVER PIERS, NUMEROUS LONGITUDINAL AND TRANSVERSE CRACKS, EXPOSED TOP OF BEAM AT NORTHEAST CORNER SPALLED. TRANSVERSE CRACKS, MINOR SPALLS WITH EXPOSED STEEL IN BOTTOM OF DECK, NO MAIN REINFORCING BARS EXPOSED, SEEPAGE BETWEEN BEAMS WITH EFFLORESCENCE. TRANSVERSE CRACKS, MINOR SPALLS WITH EXPOSED STEEL IN BOTTOM OF DECK, NO MAIN REINFORCING BARS EXPOSED, SEEPAGE BETWEEN BEAMS WITH EFFLORESCENCE. BOTH END BENTS UNDERPINNED WITH CONCRETE AND SHEET PILES, PIER 2 WITH MINOR EXPOSED STEEL, COLUMNS 3 AND 4 AT PIER 3 WITH LARGE SPALLS AT WATERLINE. MINOR EROSION, SILT BUILDUP IN EAST SPAN.

POOR-BOTH END BENTS UNDERPINNED WITH CONCRETE AND SHEET PILES, PIER 2 WITH MINOR EXPOSED STEEL, COLUMNS 1 AND 2 AT PIER 3 WITH LARGE SPALLS AT WATERLINE  
 Material: CAP ON CONCRETE COLUMNS

RECOMMEND REPLACING STRUCTURE IN 2026 DUE TO ADVANCING DETERIORATION.
